DEPARTMENT OF TRANSPORTATION**DIVISION OF ENGINEERING SERVICES**

Contract #: 04-0120F4Cty: SF/ALA Rte: 80 PM: 13.2/13.9File #: 69.28**WELDING INSPECTION REPORT****Resident Engineer:**Siegenthaler, Peter**Address:** 333 Burma Road**City:** Oakland, CA 94607**Report No:** WIR-018577**Date Inspected:** 01-Dec-2010**Project Name:** SAS Superstructure**OSM Arrival Time:** 700**Prime Contractor:** American Bridge/Fluor Enterprises, a JV**OSM Departure Time:** 1900**Contractor:** Zhenhua Port Machinery Company, Ltd (ZPMC), Changxing Island **Location:** Shanghai, China**CWI Name:** Shi Lei**CWI Present:** Yes No**Inspected CWI report:** Yes No N/A**Rod Oven in Use:** Yes No N/A**Electrode to specification:** Yes No N/A**Weld Procedures Followed:** Yes No N/A**Qualified Welders:** Yes No N/A**Verified Joint Fit-up:** Yes No N/A**Approved Drawings:** Yes No N/A**Approved WPS:** Yes No N/A**Delayed / Cancelled:** Yes No N/A**Bridge No:** 34-0006**Component:** OBG COMPONENT**Summary of Items Observed:**

In process Inspection

Trial Assembly Yard

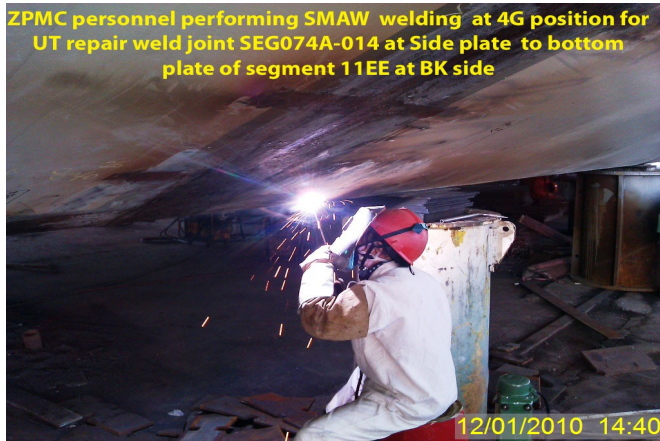
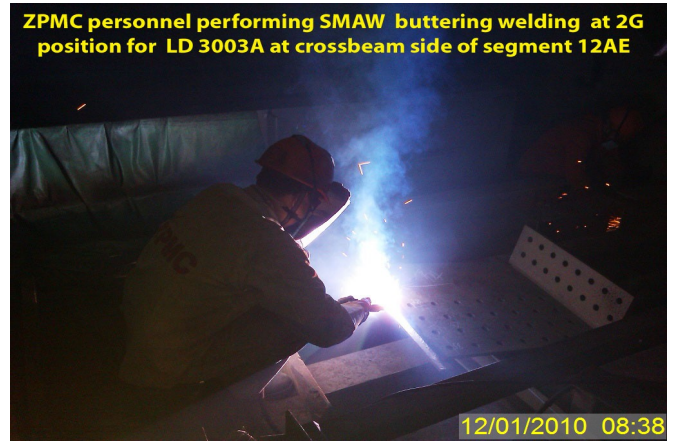
Unless otherwise noted, all work observed on this date appeared to generally comply with applicable contract documents.
